Inspection Report Minerals Regulatory Program

May 16, 2008

Mine Name: Lime Ridge	Permit number: M0370081
Operator Name: Holliday Construction	Inspection Date: April 28, 2

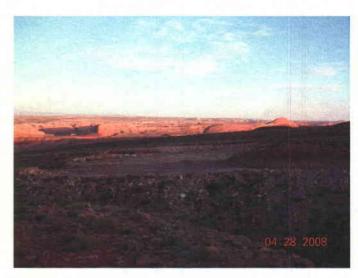
Photo 3. A portion of the area that has been mined.

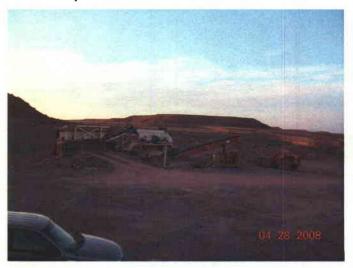
Photo 4. Another view of the crushing and screening equipment.
